ELECTRO INDUSTRIES - FIELD SERVICE BULLETIN

Bulletin Number: 1118 – (Supersedes – 1115)

Product Name WarmFlo II Plenum Heaters

Affected Product Model Numbers: EM-WU***5*, EM-WD***5*

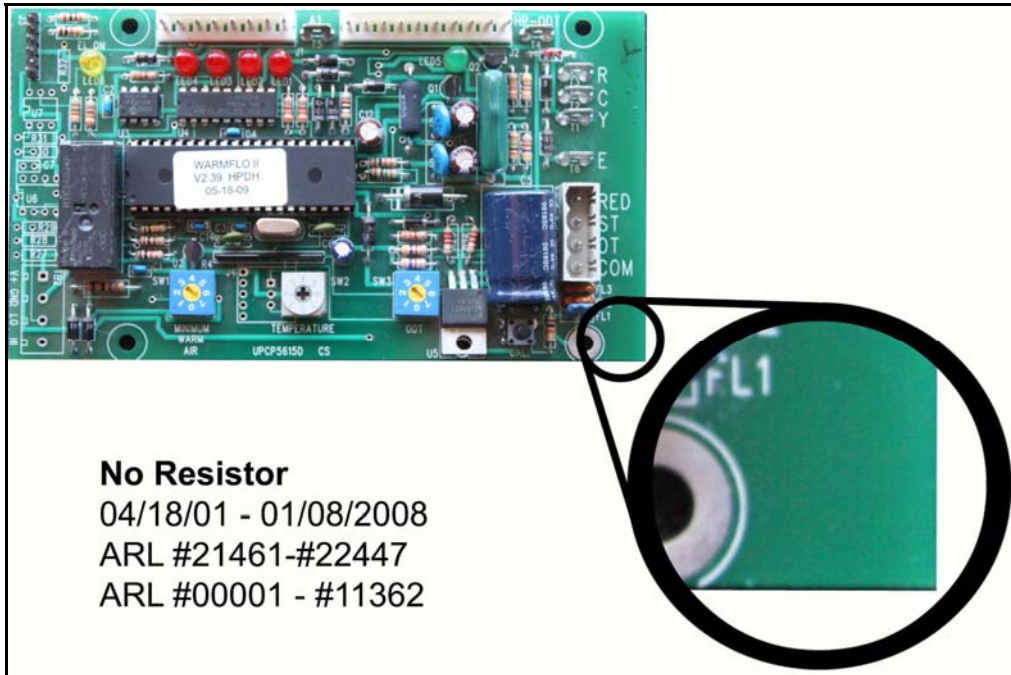
Figure 1

Control boards that do **not** have a resistor as shown under **Figure 1** are not affected by this issue and will not be covered under this Field Service Bulletin. If your plenum heater is displaying the symptoms above, and includes a 1K resistor as shown under **Figure 2**, your control board will be covered under this Field Service Bulletin. Control boards that have a zero Ohm resistor as shown under **Figure 3** are the latest version of this control board. This version is not affected and will not be covered under this Field Service Bulletin.

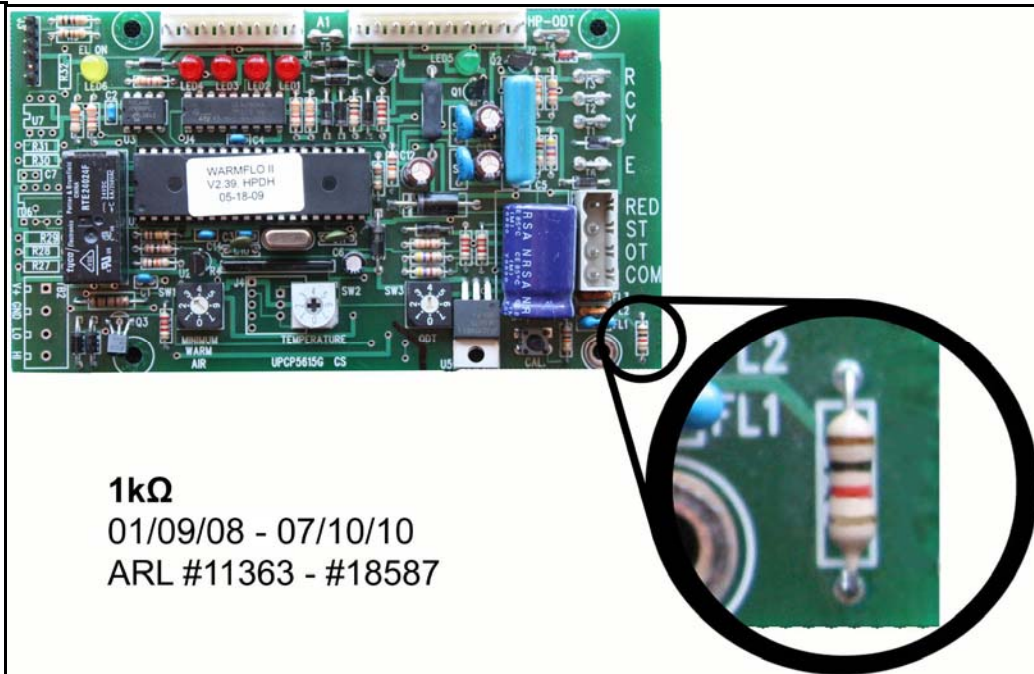
Figure 2

During the past few heating seasons we have experienced an unusual condition within the software of our WarmFlo II plenum heaters. For some unknown reason, -01°F is written into stage one outdoor temperature disable section of the software. We have come to the conclusion that a key factor of this issue is due to a resistor that was added in 2008 to help assist in troubleshooting. This 1K resistor may cause a slight variation in control voltage.

This -01°F value can easily be removed with the WarmFlo Analyzer, but it is possible the -01°F will return at some point. The permanent fix is to replace the existing control board with a new updated version. This new control board has had the suspect resistor removed and includes additional software protection. Each control board will be covered under warranty and includes a \$50 reimbursement for labor on any WarmFlo II plenum heater that has a serial number that falls within the specified range. Standard warranty procedures apply.

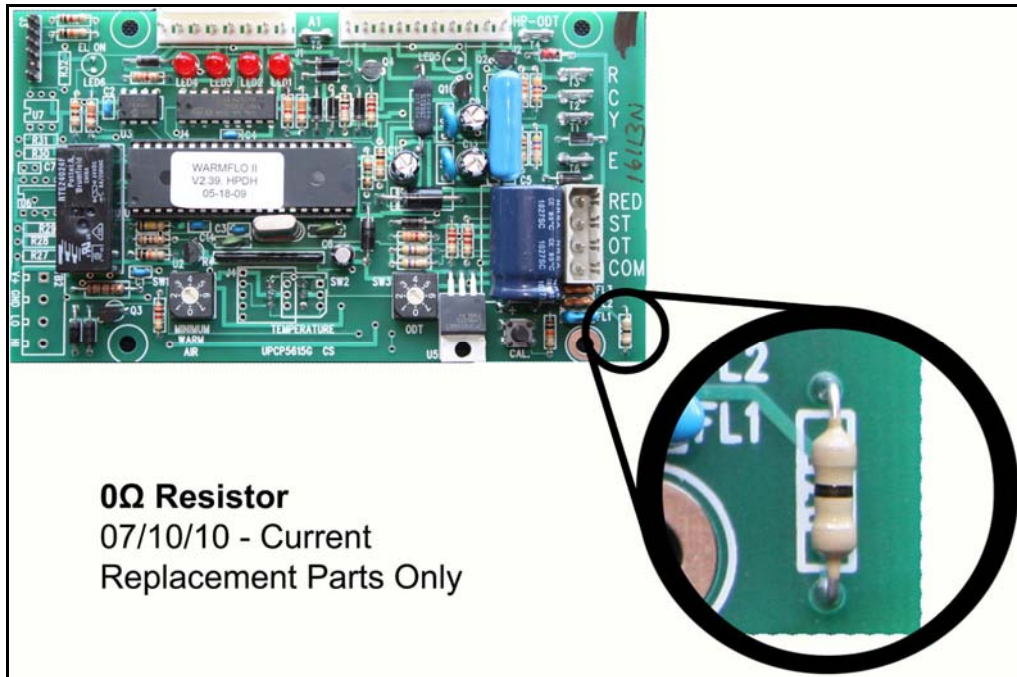
Figure 3

0Ω Resistor
07/10/10 - Current
Replacement Parts Only
